**THE COLONISATION OF PAINT FILMS BY
MICROORGANISMS IN THE UK AND NORWAY.**

**A THESIS SUBMITTED TO THE UNIVERSITY OF
CENTRAL LANCASHIRE IN PRESTON IN PART
FULFILMENT FOR THE AWARD OF DOCTOR OF
PHILOSOPHY**

MARCH 2002

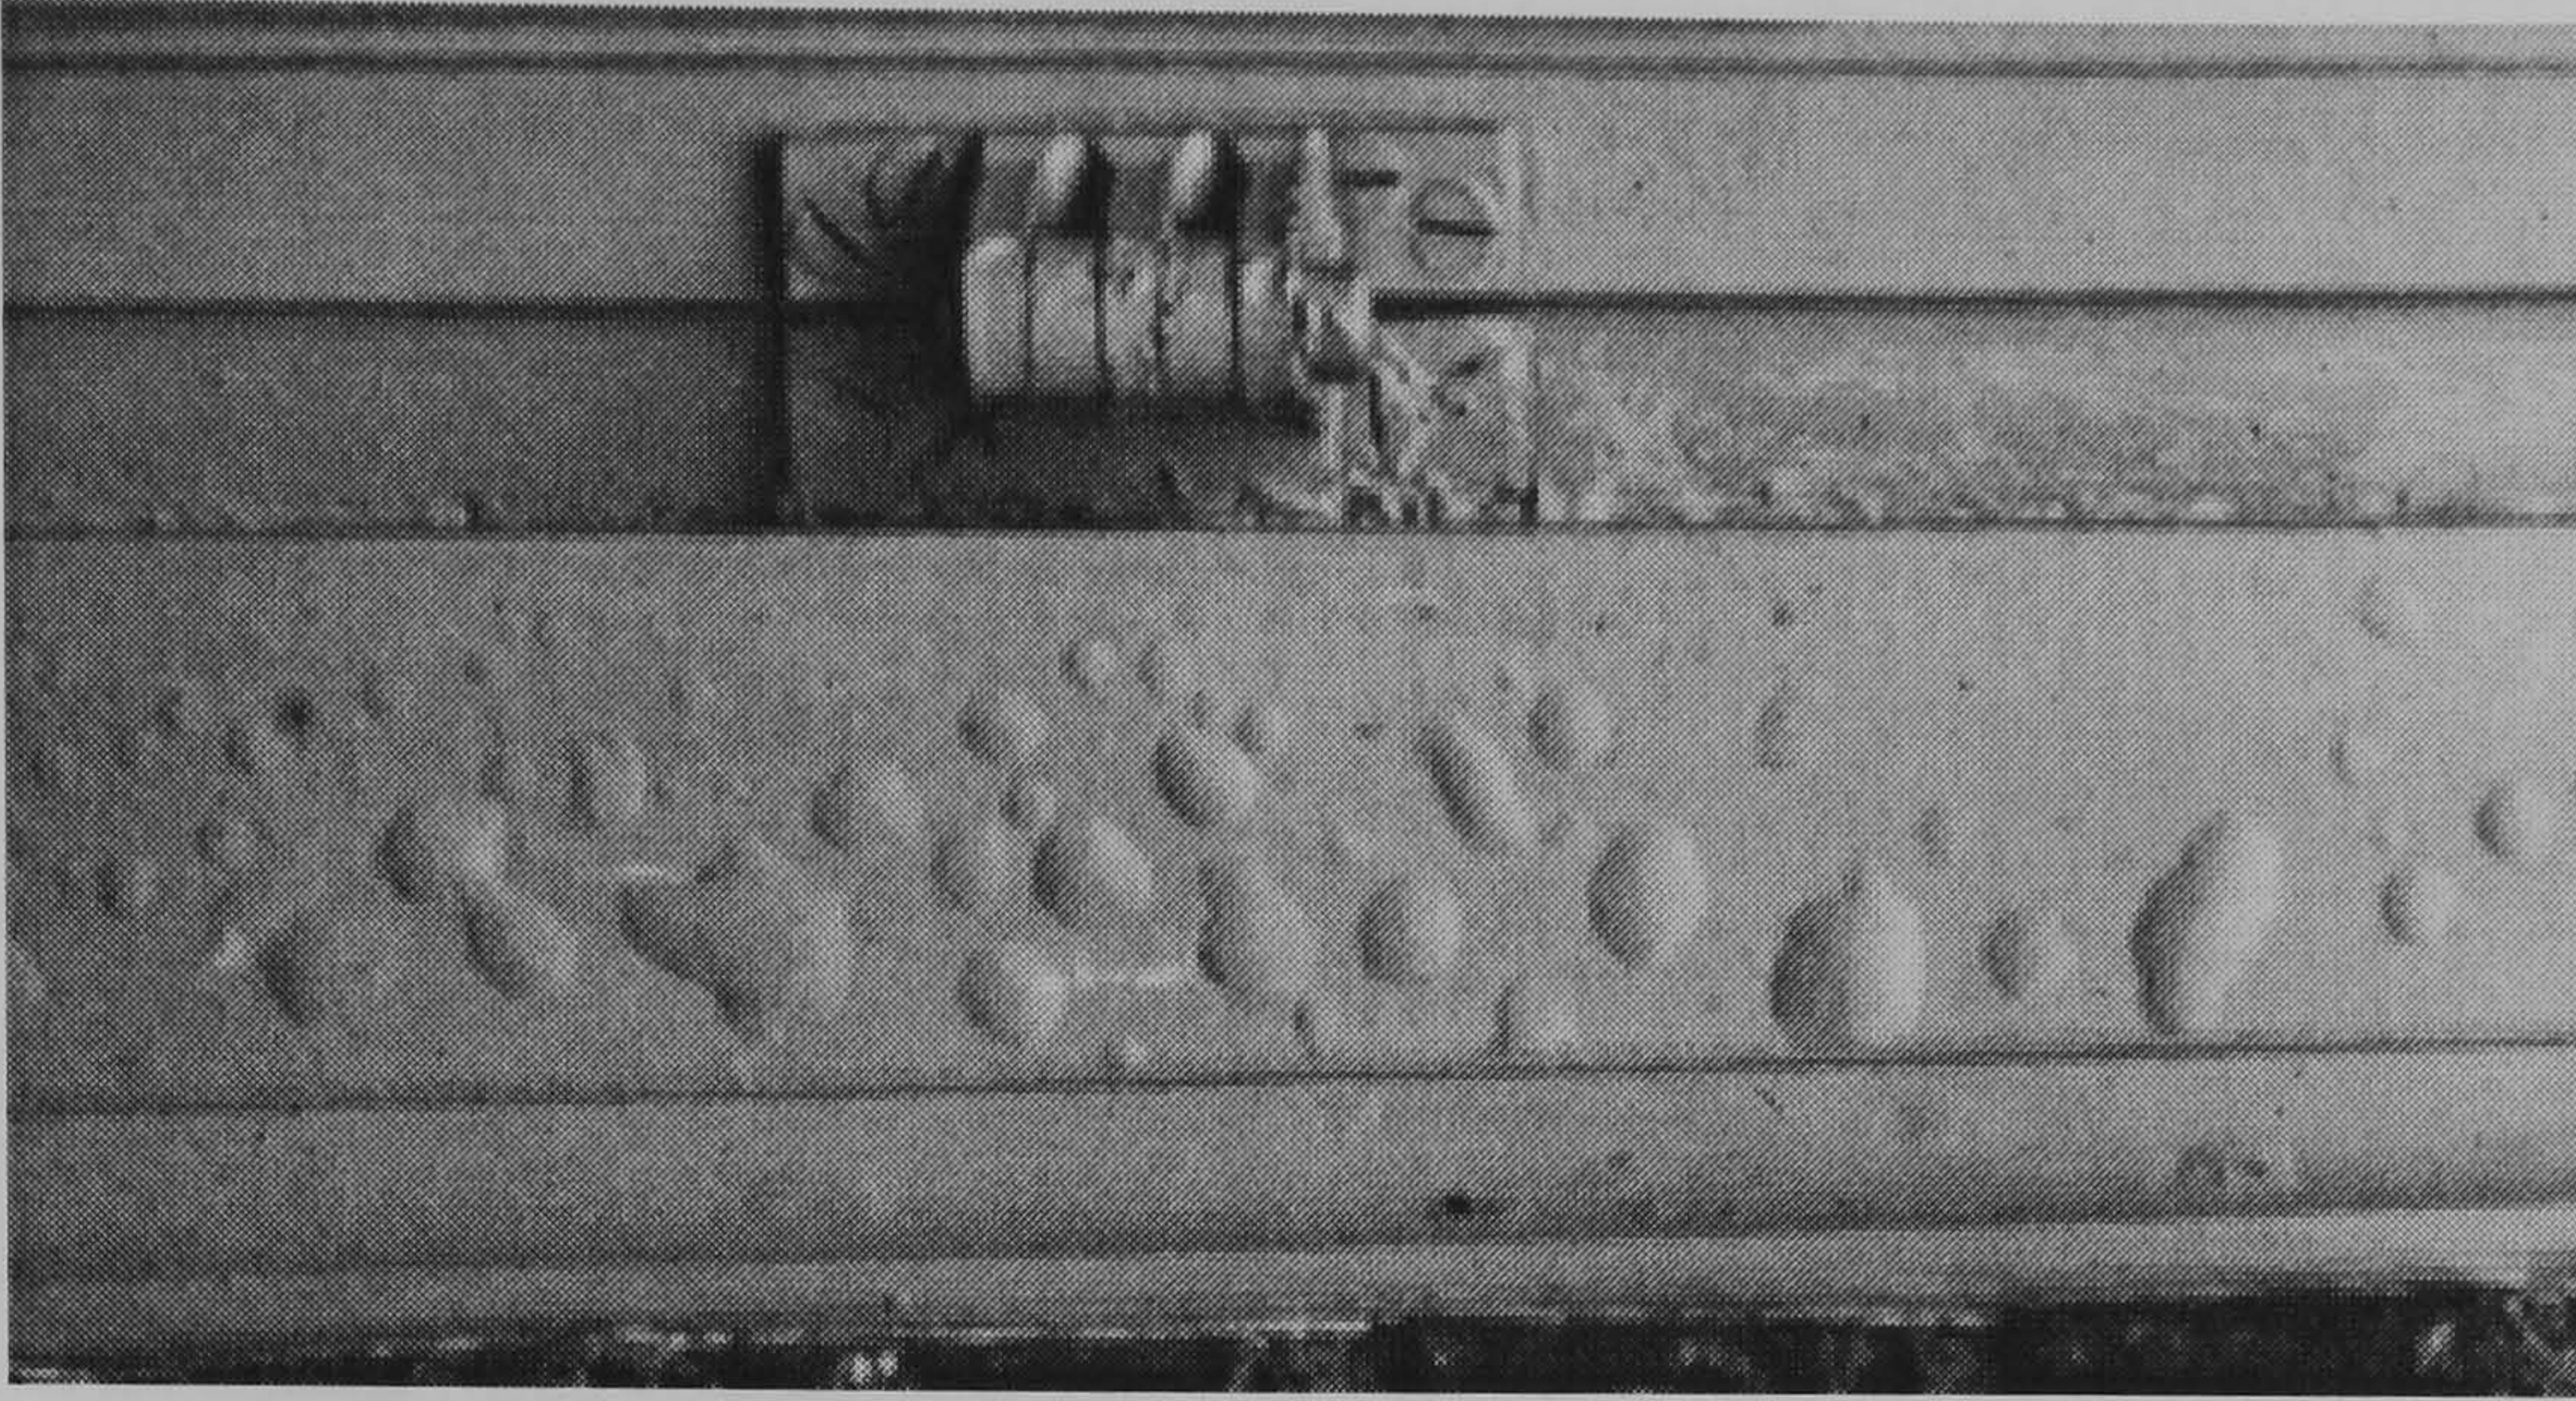
Figure 1.2 Blistering occurring on a painted wooden surface (Drummond, 1962).

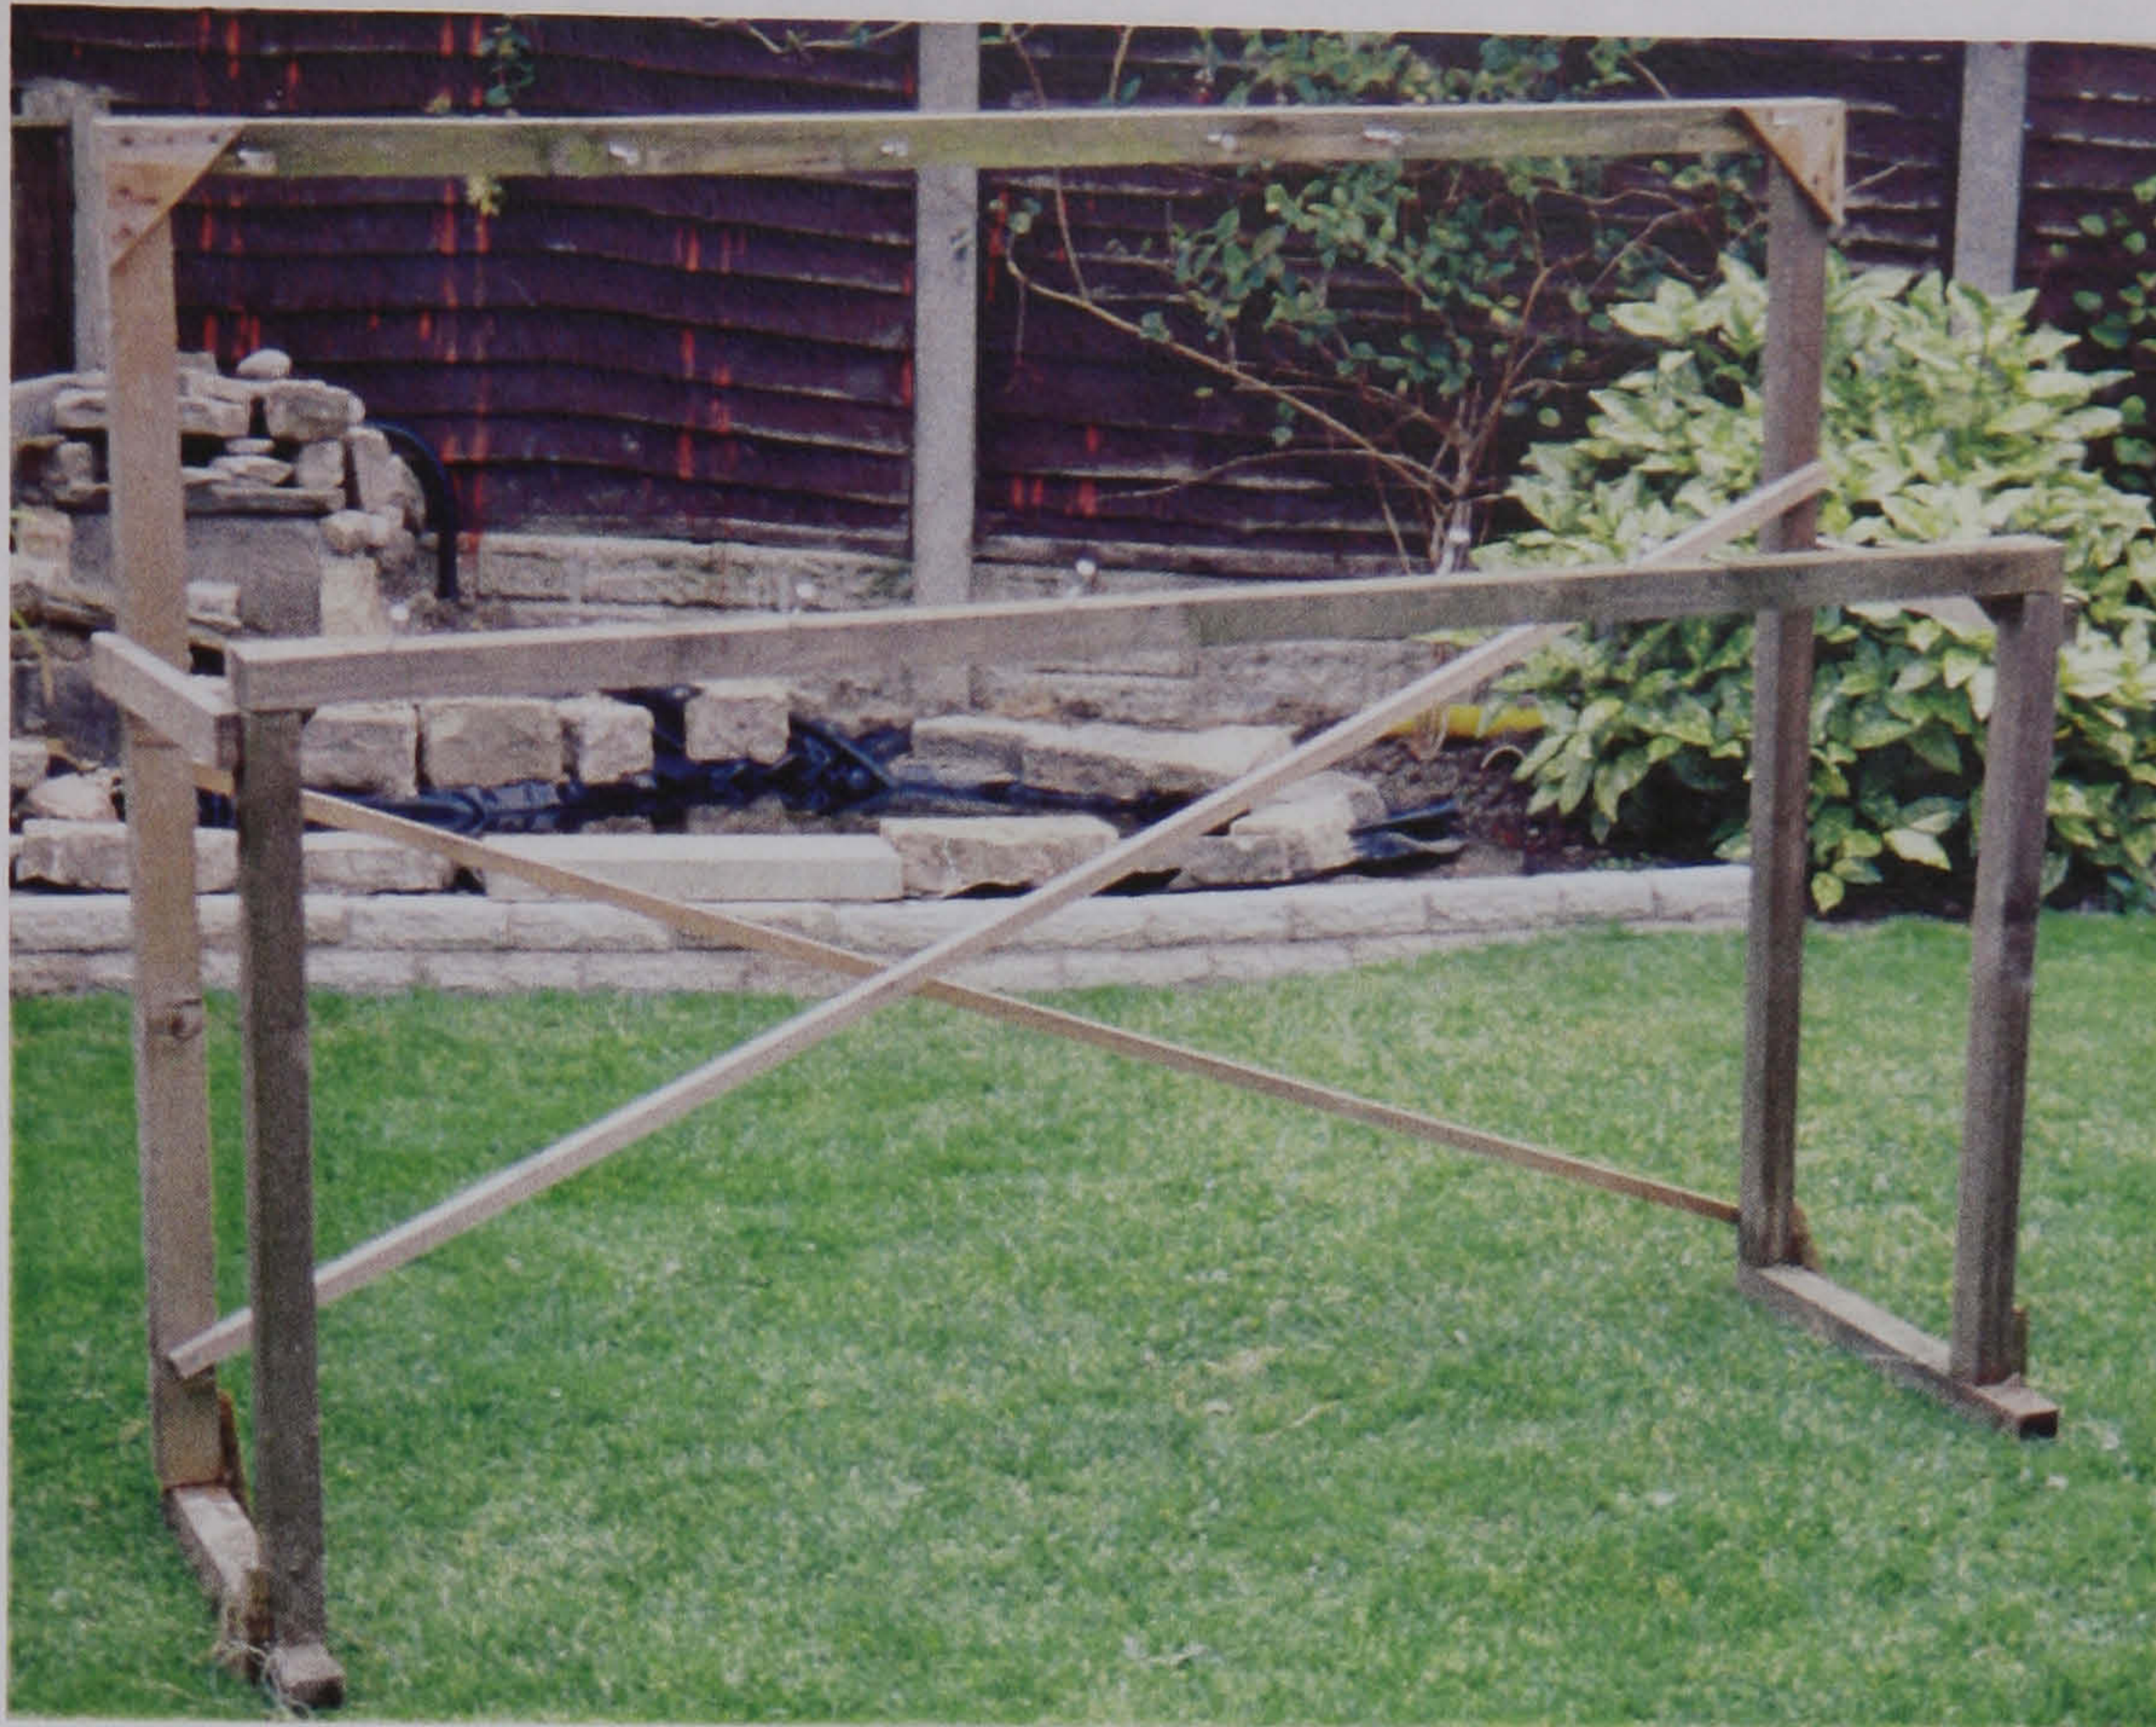
Plate 2.2 The standing rack holder.

At the Walton-le-Dale site in Preston, a standing rack holder (Figure 2.3 and Plate 2.2) had to be built to hold the panel racks at a forty-five degree angle, facing North. As the standing rack holders in Sandefjord, Norway and Blackley UK, stand at a metre above the ground surface the rack to be built also had to stand at a metre from the ground.

The racks were fixed onto the frame using two nails per panel rack as supports along the bottom edge of the frame and tie wraps to hold the racks in place.

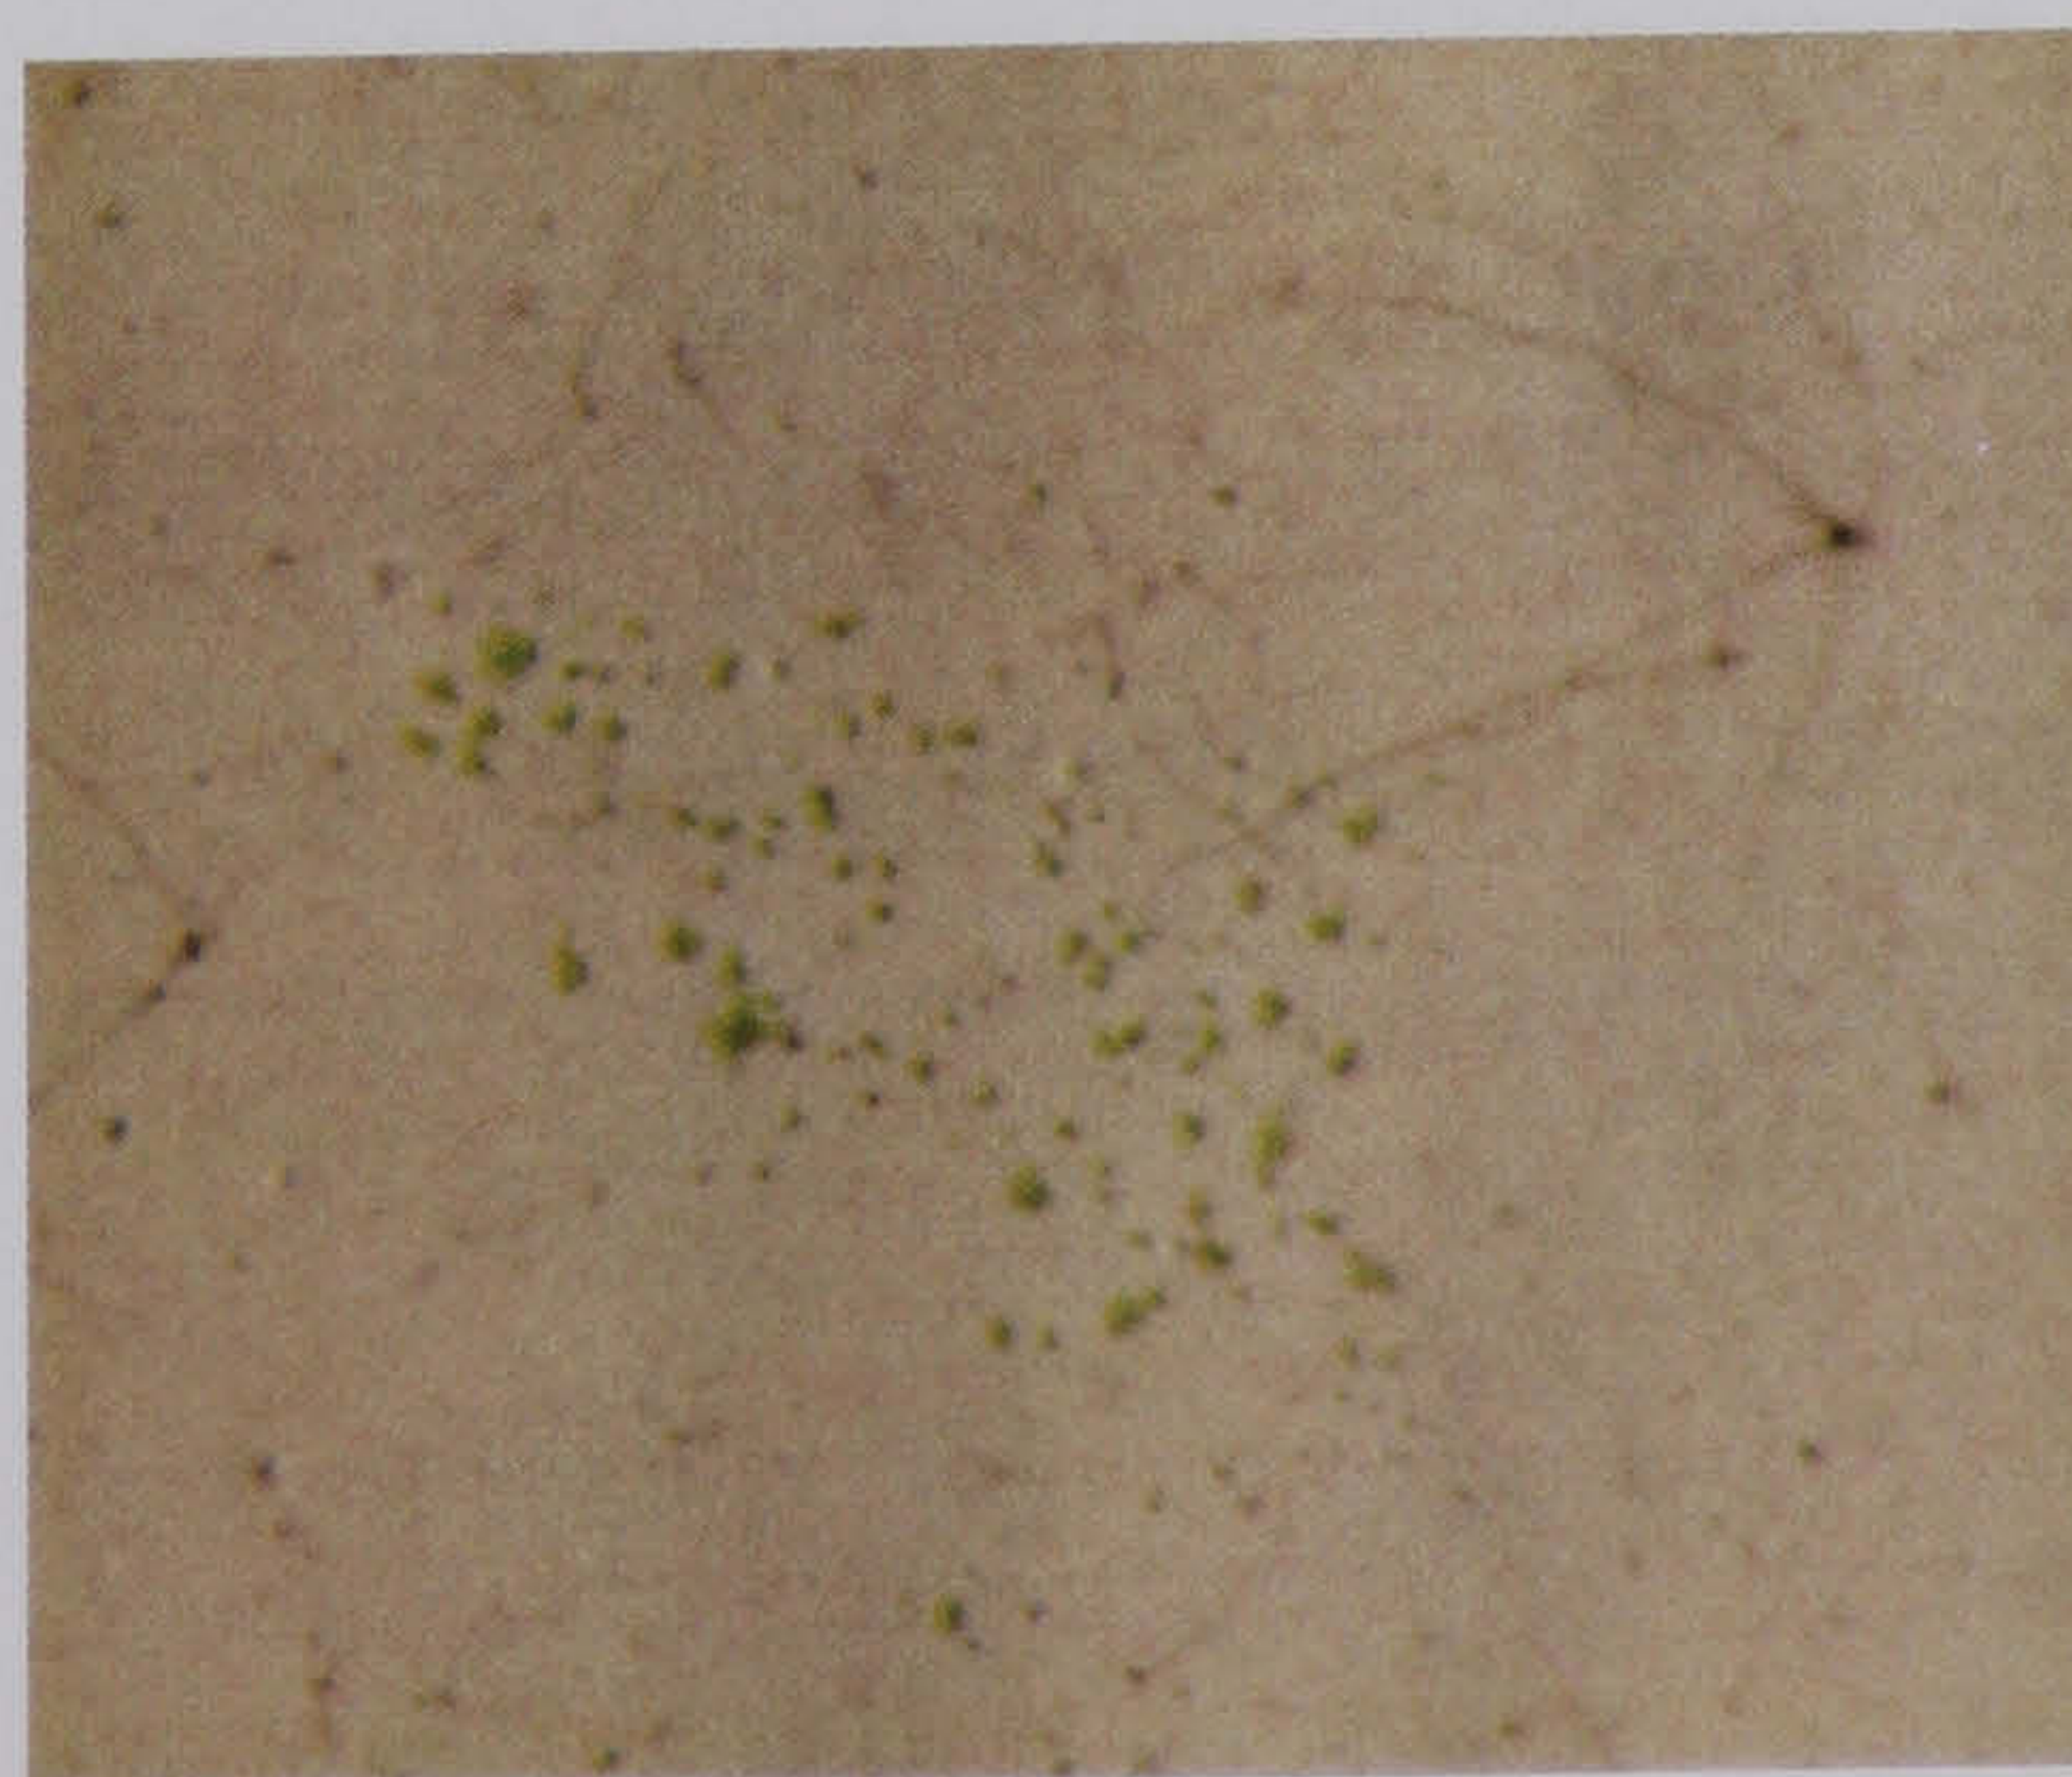
Plate 2.4 A spruce panel painted with the acrylic paint without fungicide after a month’s exposure (x100) at Sandefjord.

Plates 2.3 and 2.4 are photomicrographs of one of the spruce panels painted with paint B; Plate 2.5 is a photomicrograph of a panel painted with paint F, a gloss paint. It can be seen from these plates that algae and fungi are colonising the panels after one month’s exposure and there appear to be many hyphal branches spreading across the gloss paint.

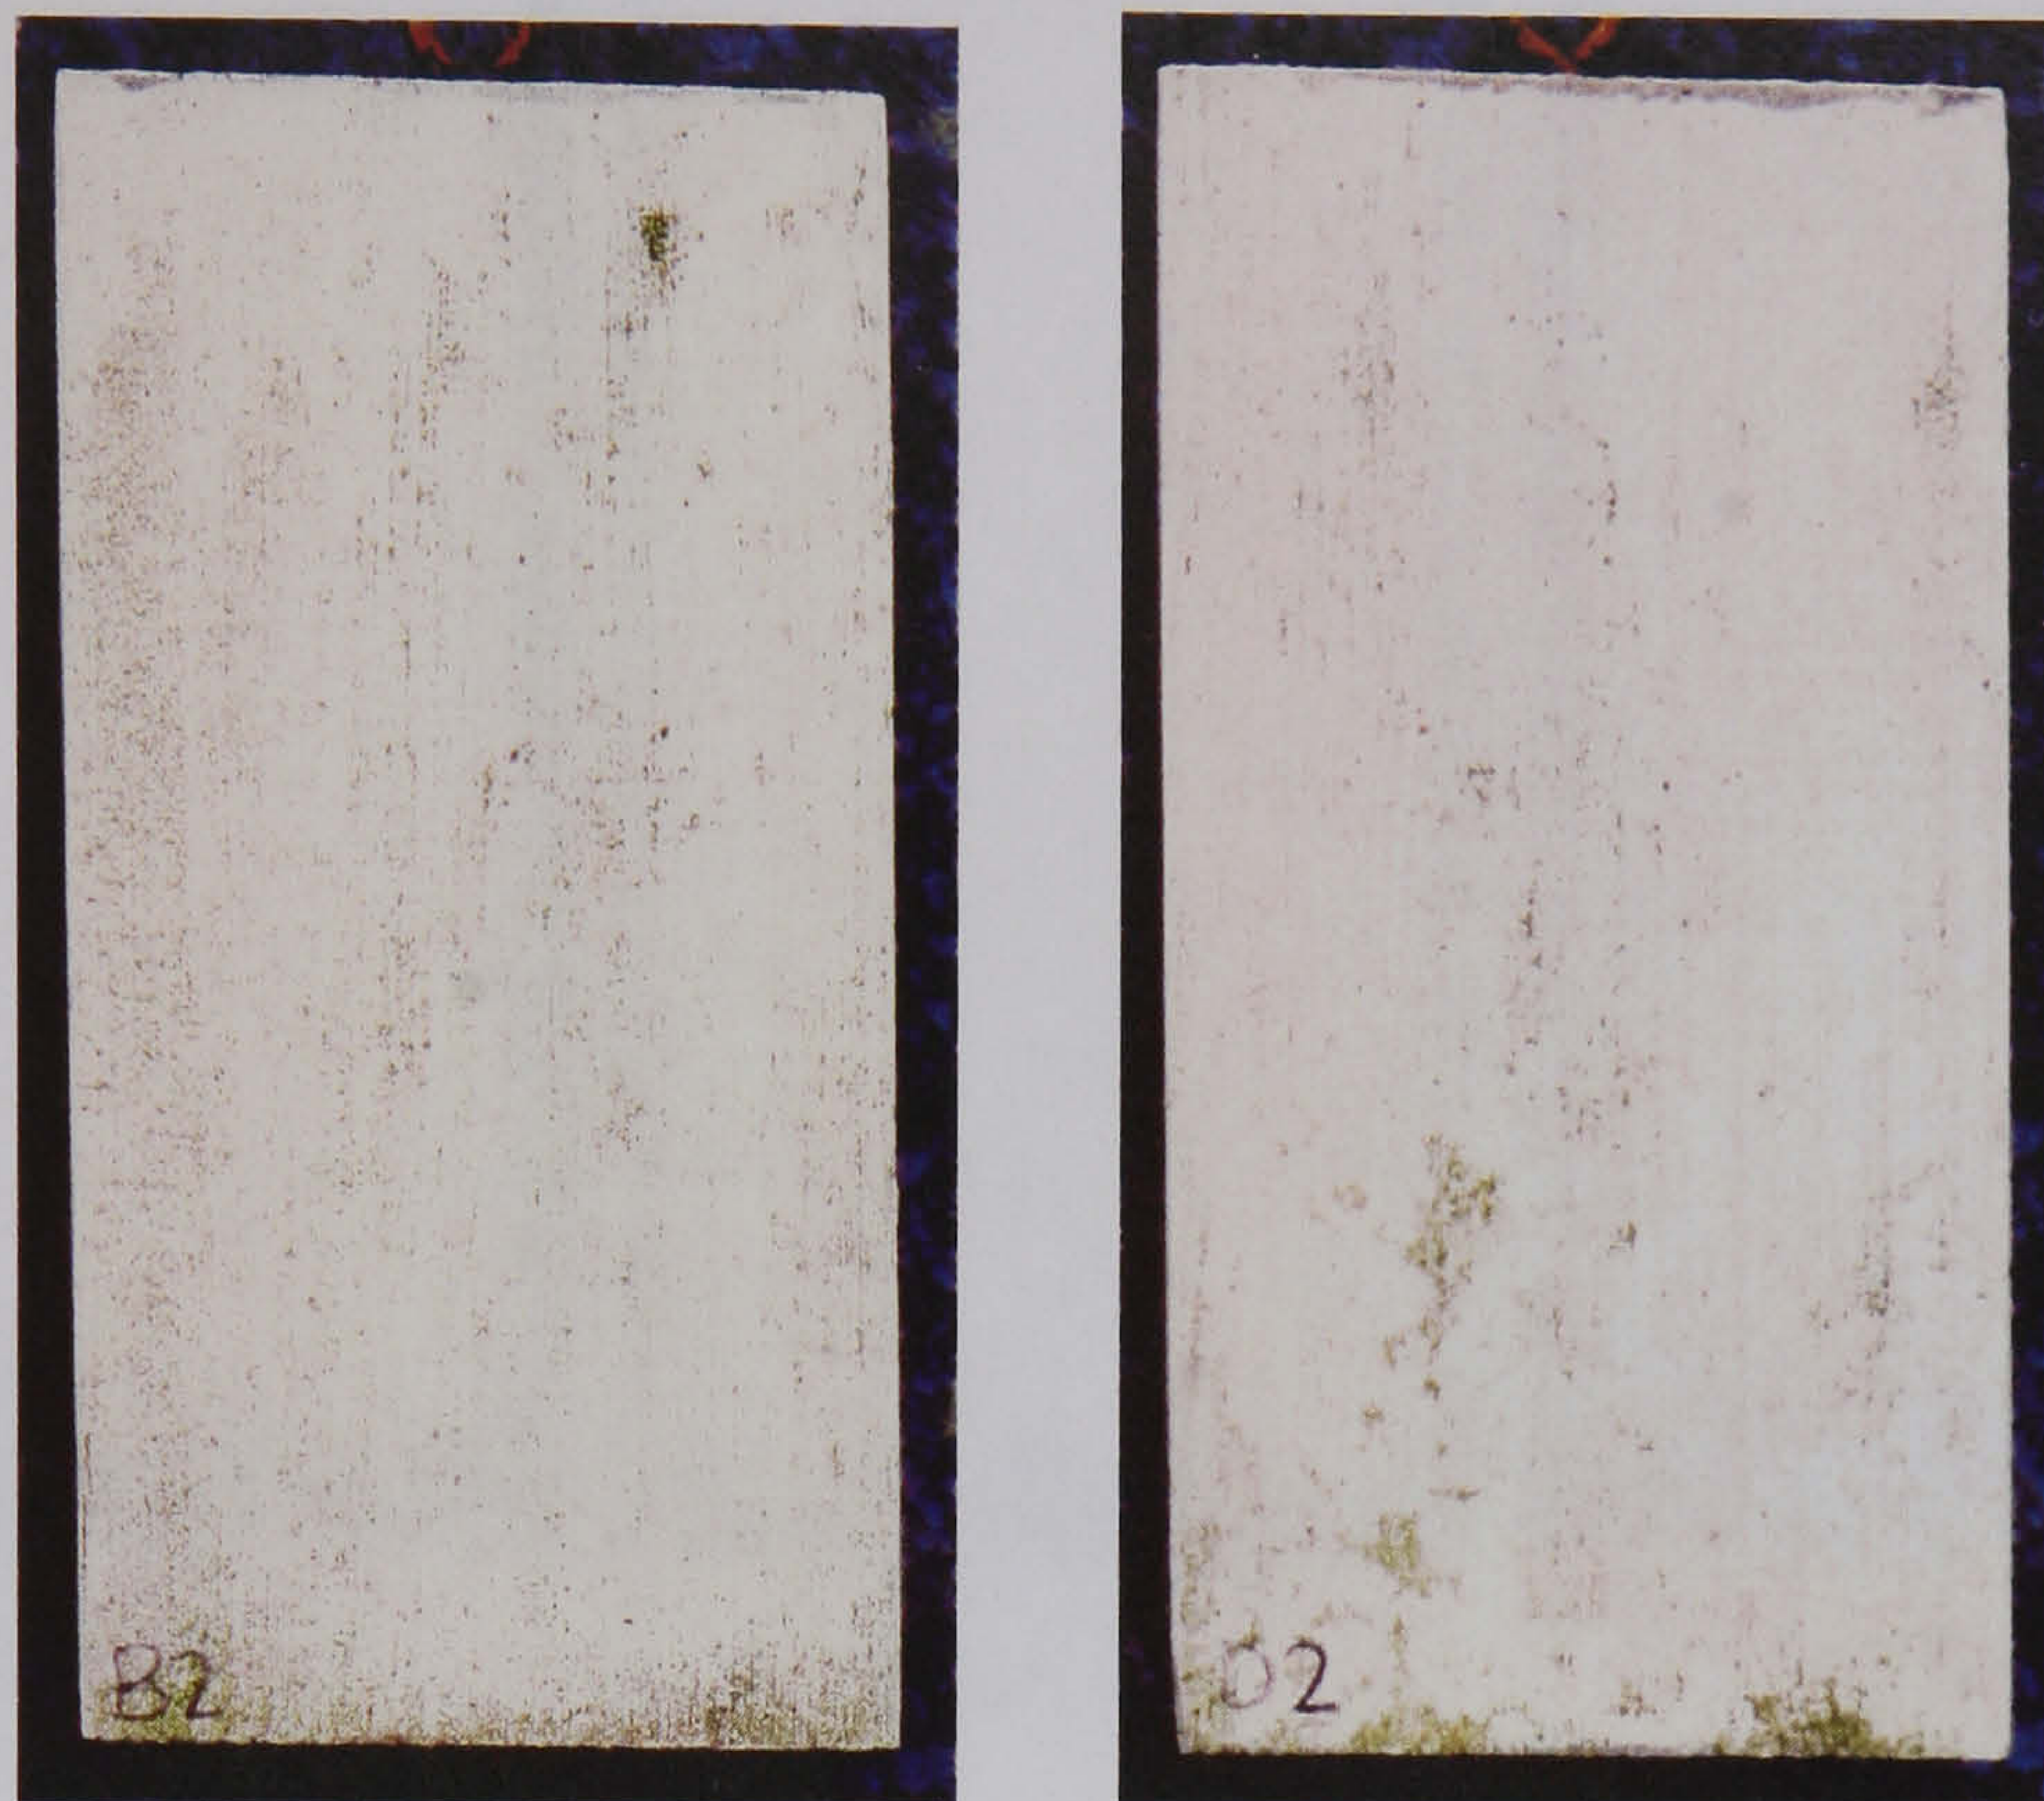
Plate 2.9 The two non-fungicide containing acrylic paints after twenty-three months exposure at Preston.

Plate 2.9 shows the two non-fungicide containing acrylic paints (paints B and D) painted onto the spruce panels after their full exposure period. Inspection of the panels with a low power stereoscopic microscope showed that the panels were colonised by algae and fungi and that there was surface debris present. This degree of colonisation was not apparent on the paints containing fungicide (paints A and C).

Visual comparisons of the degree of colonisation of the two paint types showed that the hybrid paint (D) was less colonised than the pure biocide-free paint (B) when coated onto spruce panels (Plate 2.9). On calcium silicate panels (Plate 2.11) it can be seen that paint B was the most heavily colonised followed by paint A and then paint C. Plate 2.12 shows paints B, C and D coated onto spruce panels, from these images it can be seen that both paint B and D are heavily colonised in comparison to paint C, however, it is not possible to distinguish which paint was the least susceptible to colonisation by microorganisms. Plate 2.13 shows paints A, B, C and D coated on calcium silicate panels, it is possible to see in this case that paint D is more heavily colonised than paint B, however, paints A and C appear to be similarly colonised and therefore it is not possible to distinguish between the susceptibility of these two paints.

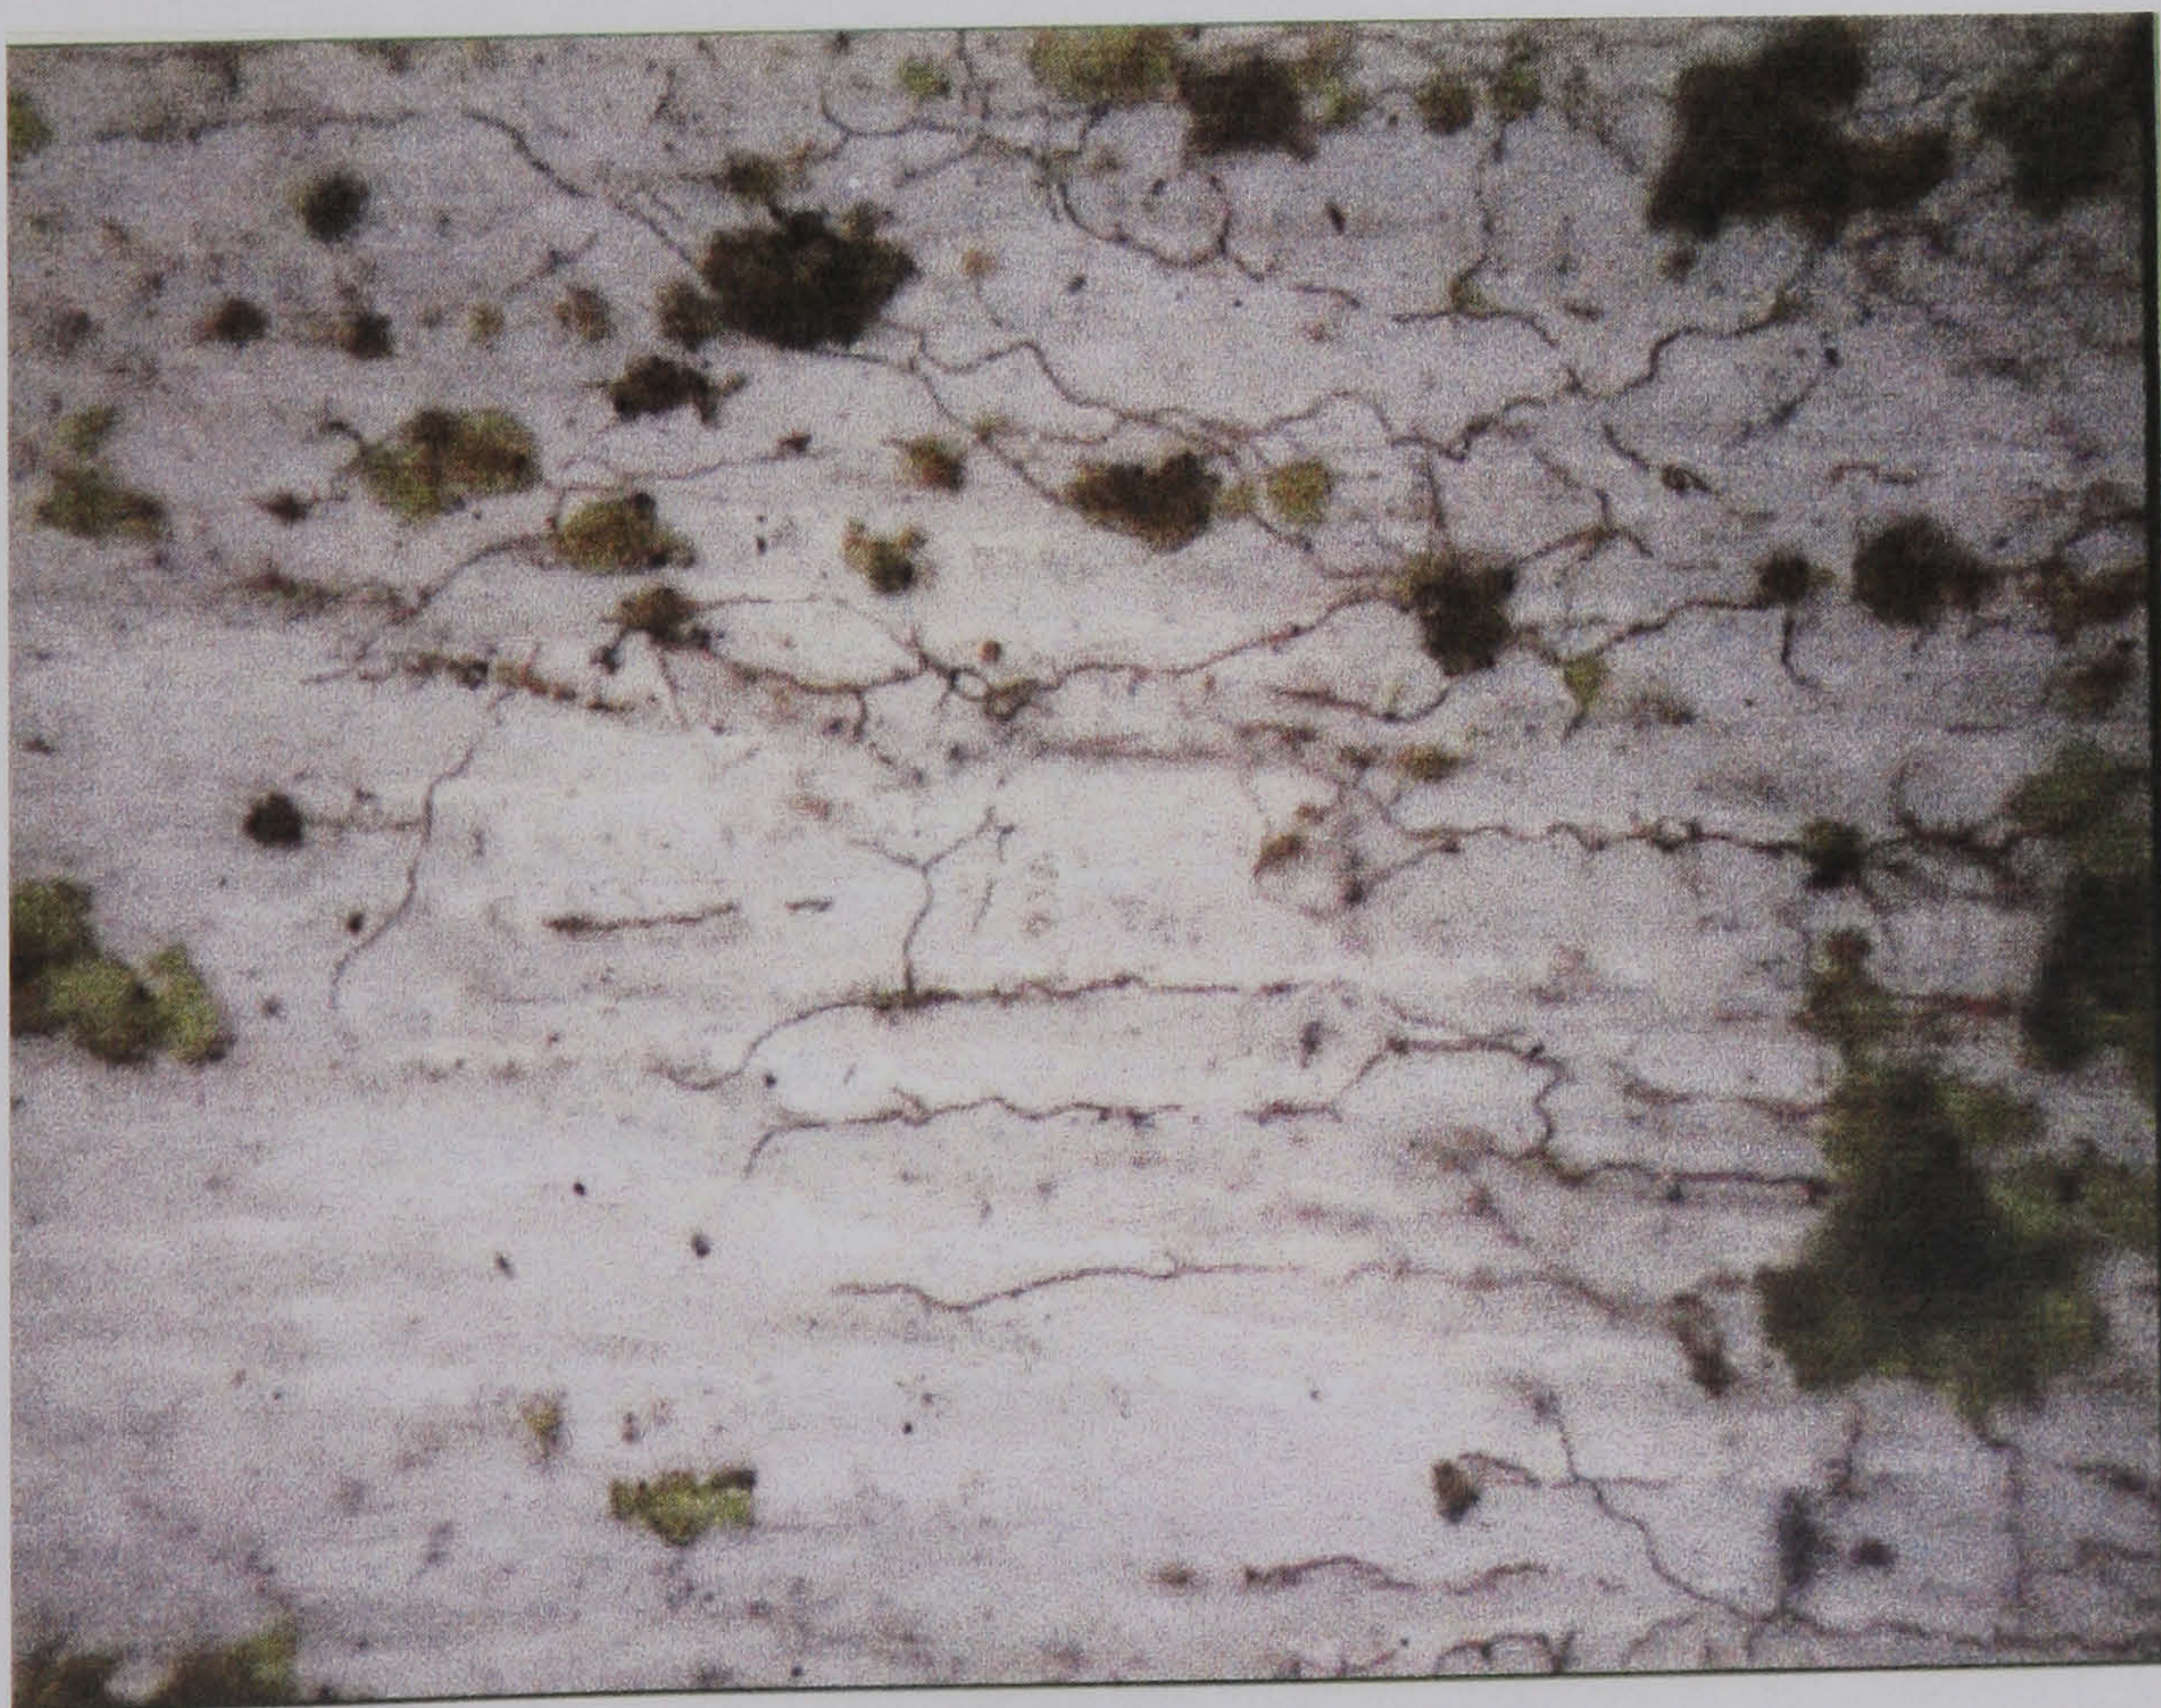
Figure 4.23 An image of the exposed painted surface showing the growth of fungal hyphae along the 'peaks' of the wood grain.

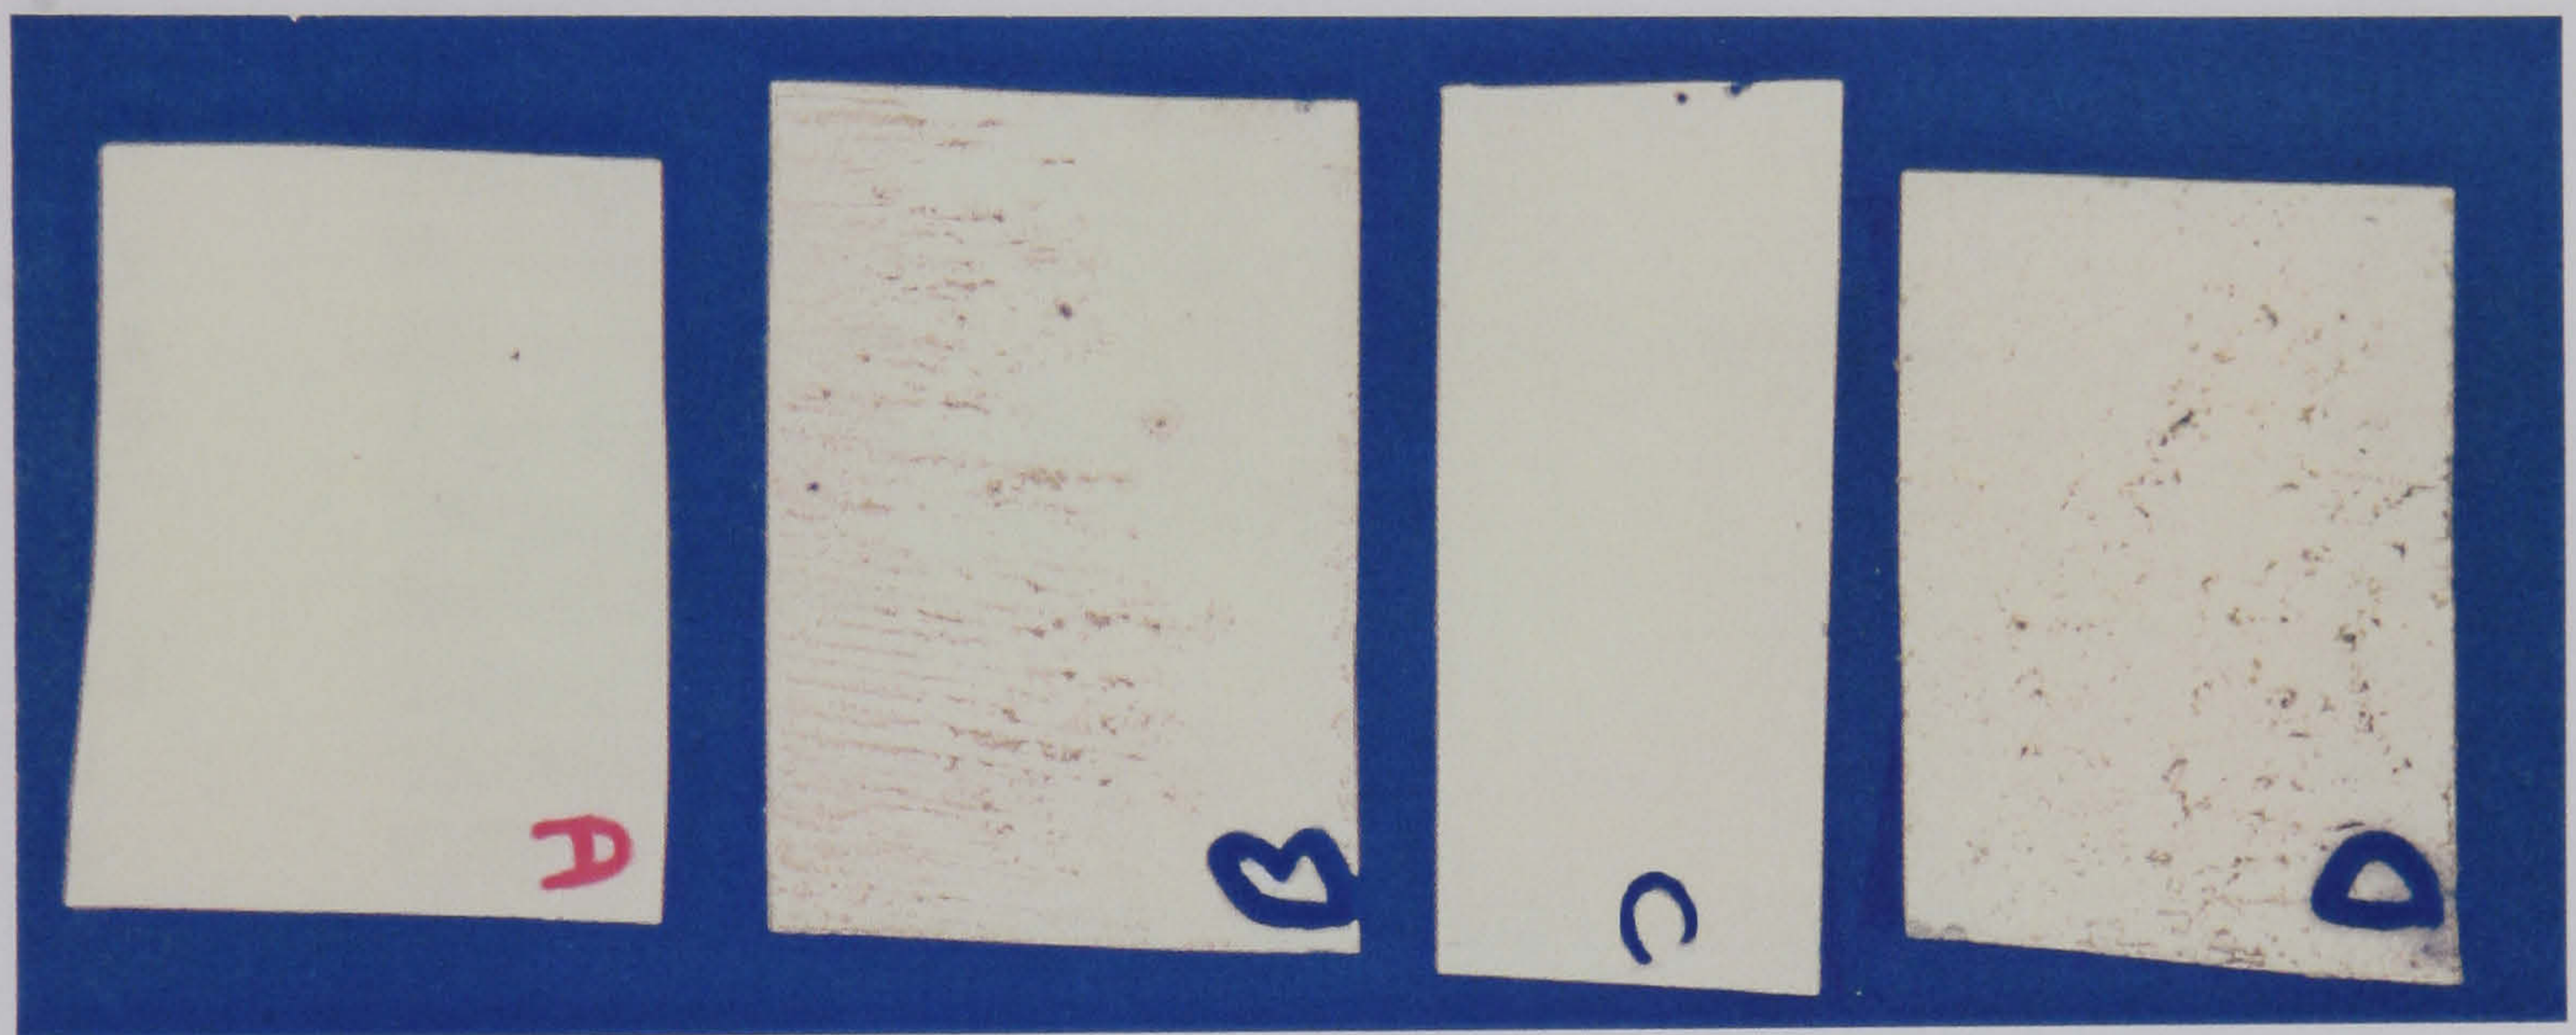
Figure 4.47 Paints A to D after inoculation with *Aureobasidium pullulans*.

The tables in Appendix I present the results of these experiments. It can be seen that there was no obvious difference between any of the initial weights and the final weights. The paint films inoculated with *Aureobasidium pullulans* showed that this microorganism grew on paints B, D, E and F and not on A or C, which both contained fungicide. Figure 4.47 shows the paint films A to D inoculated with *Aureobasidium pullulans*, displaying this.

From the results of this section of the work it can be seen that *Aureobasidium pullulans* is readily able to colonise the paints that do not contain fungicide. This is shown in Figure 4.47, which shows paints B and D (the non-fungicide containing paints) are colonised whilst the paints A and C, the paints containing fungicide are not. The paint films inoculated with *Rhodotorula rubra* and *Rhodotorula mucilaginosa* became contaminated with *Aspergillus fumigatus*. The results of the weight loss experiments (Appendix I) do not provide evidence of weight loss resulting from inoculating the paint films with any of the organisms.

The major result from this experiment was in the observation that only the non-fungicide containing paint films inoculated with *Aureobasidium pullulans* and *Aspergillus fumigatus*, were shown to be colonised. This can be seen in Figure 4.47, where paints A and C are clear, whereas paints B and D have been colonised with *Aureobasidium pullulans*. This suggests that the fungicide has been effective against *Aureobasidium pullulans*, which is deemed as one of the predominant colonisers of paint (Bravery, 1987 ; Downey, 1995). The fact that the fungicide has been found to be effective against these fungi suggests that during the exposure trials the fungi found on
